ULTIMAT SAMI - A449, Malvern, Worcestershire
The ultimate surfacing solution for concrete pavements

Product ULTIMAT SAMI & ULTIMAT 10MM

Location A449, MALVERN, WORCESTERSHIRE

Completion OCTOBER 2015

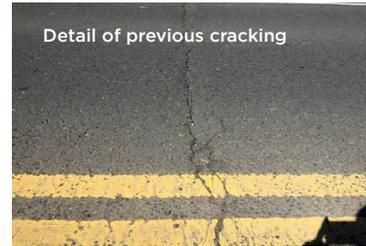
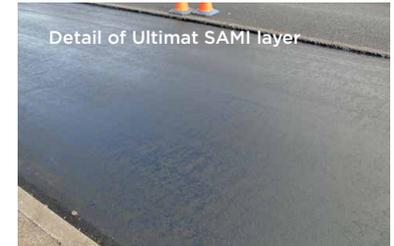
The scheme was completed over two days by Eurovia Surfacing on behalf of Ringway Infrastructure Services. Each carriageway was treated on a separate day. The existing HRA 55/14 was planed away to expose the concrete base layer. The concrete was then overlaid with 25mm ULTIMAT SAMI followed by 40mm of ULTIMAT 10mm surface course. Using ULTIMAT SAMI in conjunction with an ULTIMAT surface course, provided a lasting solution to the persistent problem of cracking. As a result, the long term condition and performance of this road, as an asset, was improved and future maintenance requirements were minimised, reducing expenditure and disruption for local people.
